# Investigation of the Emergence of Quality Defects during Plastic Injection Moulding

Viltė Subačiūtė  
Regita Bendikienė

Department of Production Engineering, Faculty of Mechanical Engineering and Design,  
Kaunas University of Technology, Studentu str. 56, LT-51525 Kaunas, Lithuania

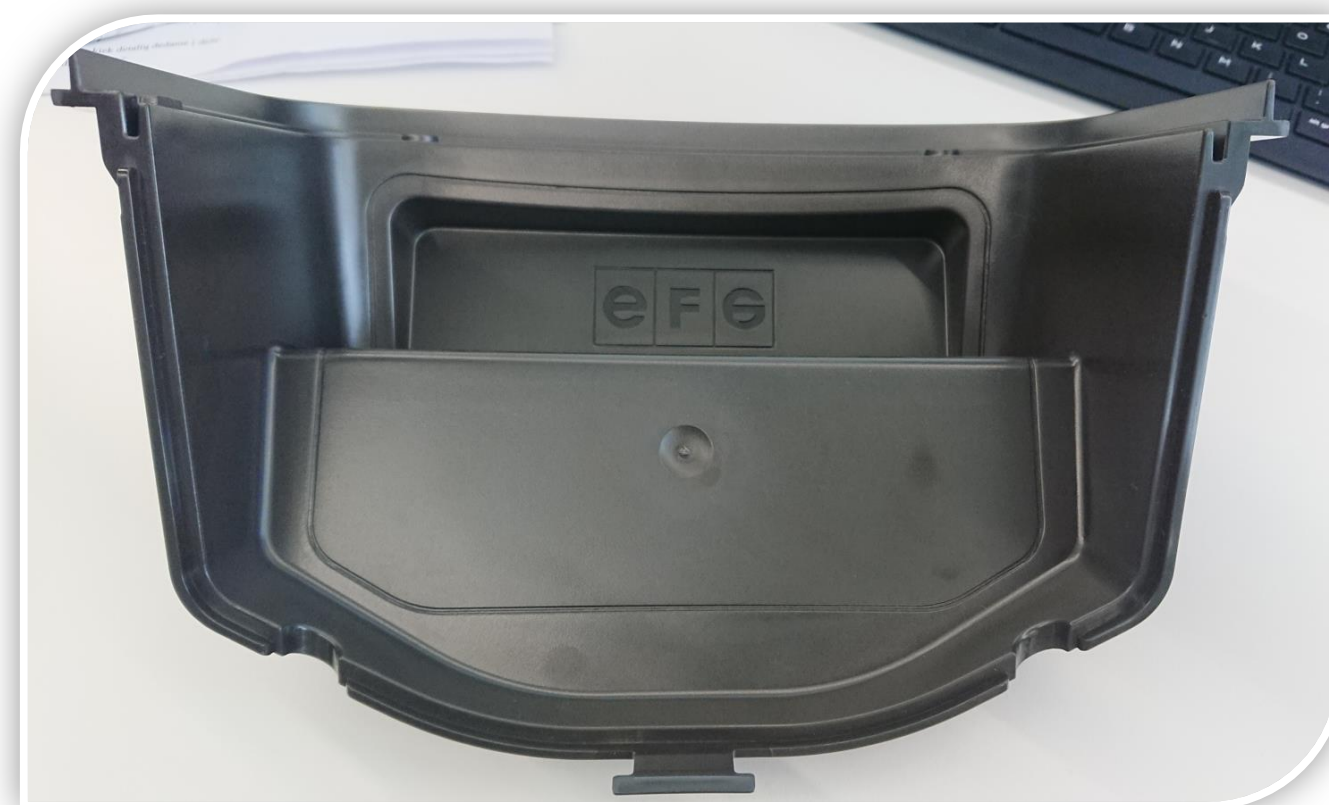
Fig. 2 Selected part for investigation

It was counted that out of 8000 pieces, 155 (or 1.9375%) were detected as defected pieces: 69, or 0.8625%, were named as 'human factor defect', 56 (0.7000%) of defected parts were process-related, various types of nonconformities like warpages, jet marks and sink marks that were quite insignificant as it hadn't fixed placement on the part and only 30 (0.3750%) were machine related (see the objective no. 1).

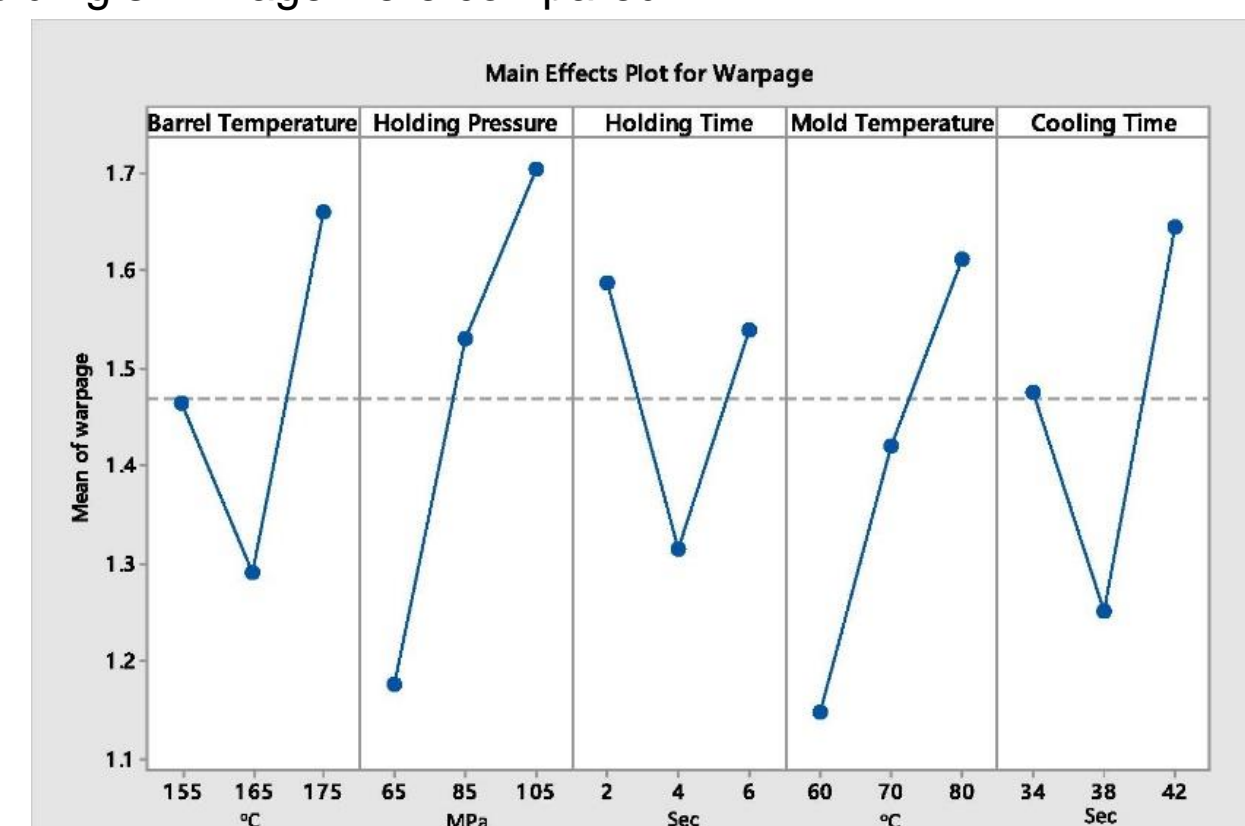
Fig. 3 Influence of various moulding parameters to the effect of warpage of moulded part

For the third objective evaluation of injection moulding parameters were selected. T. Ahmed with the research team from Jashore University of Science and Technology in 2022 carried out the process parameter effect research. Results are presented in Fig. 3.

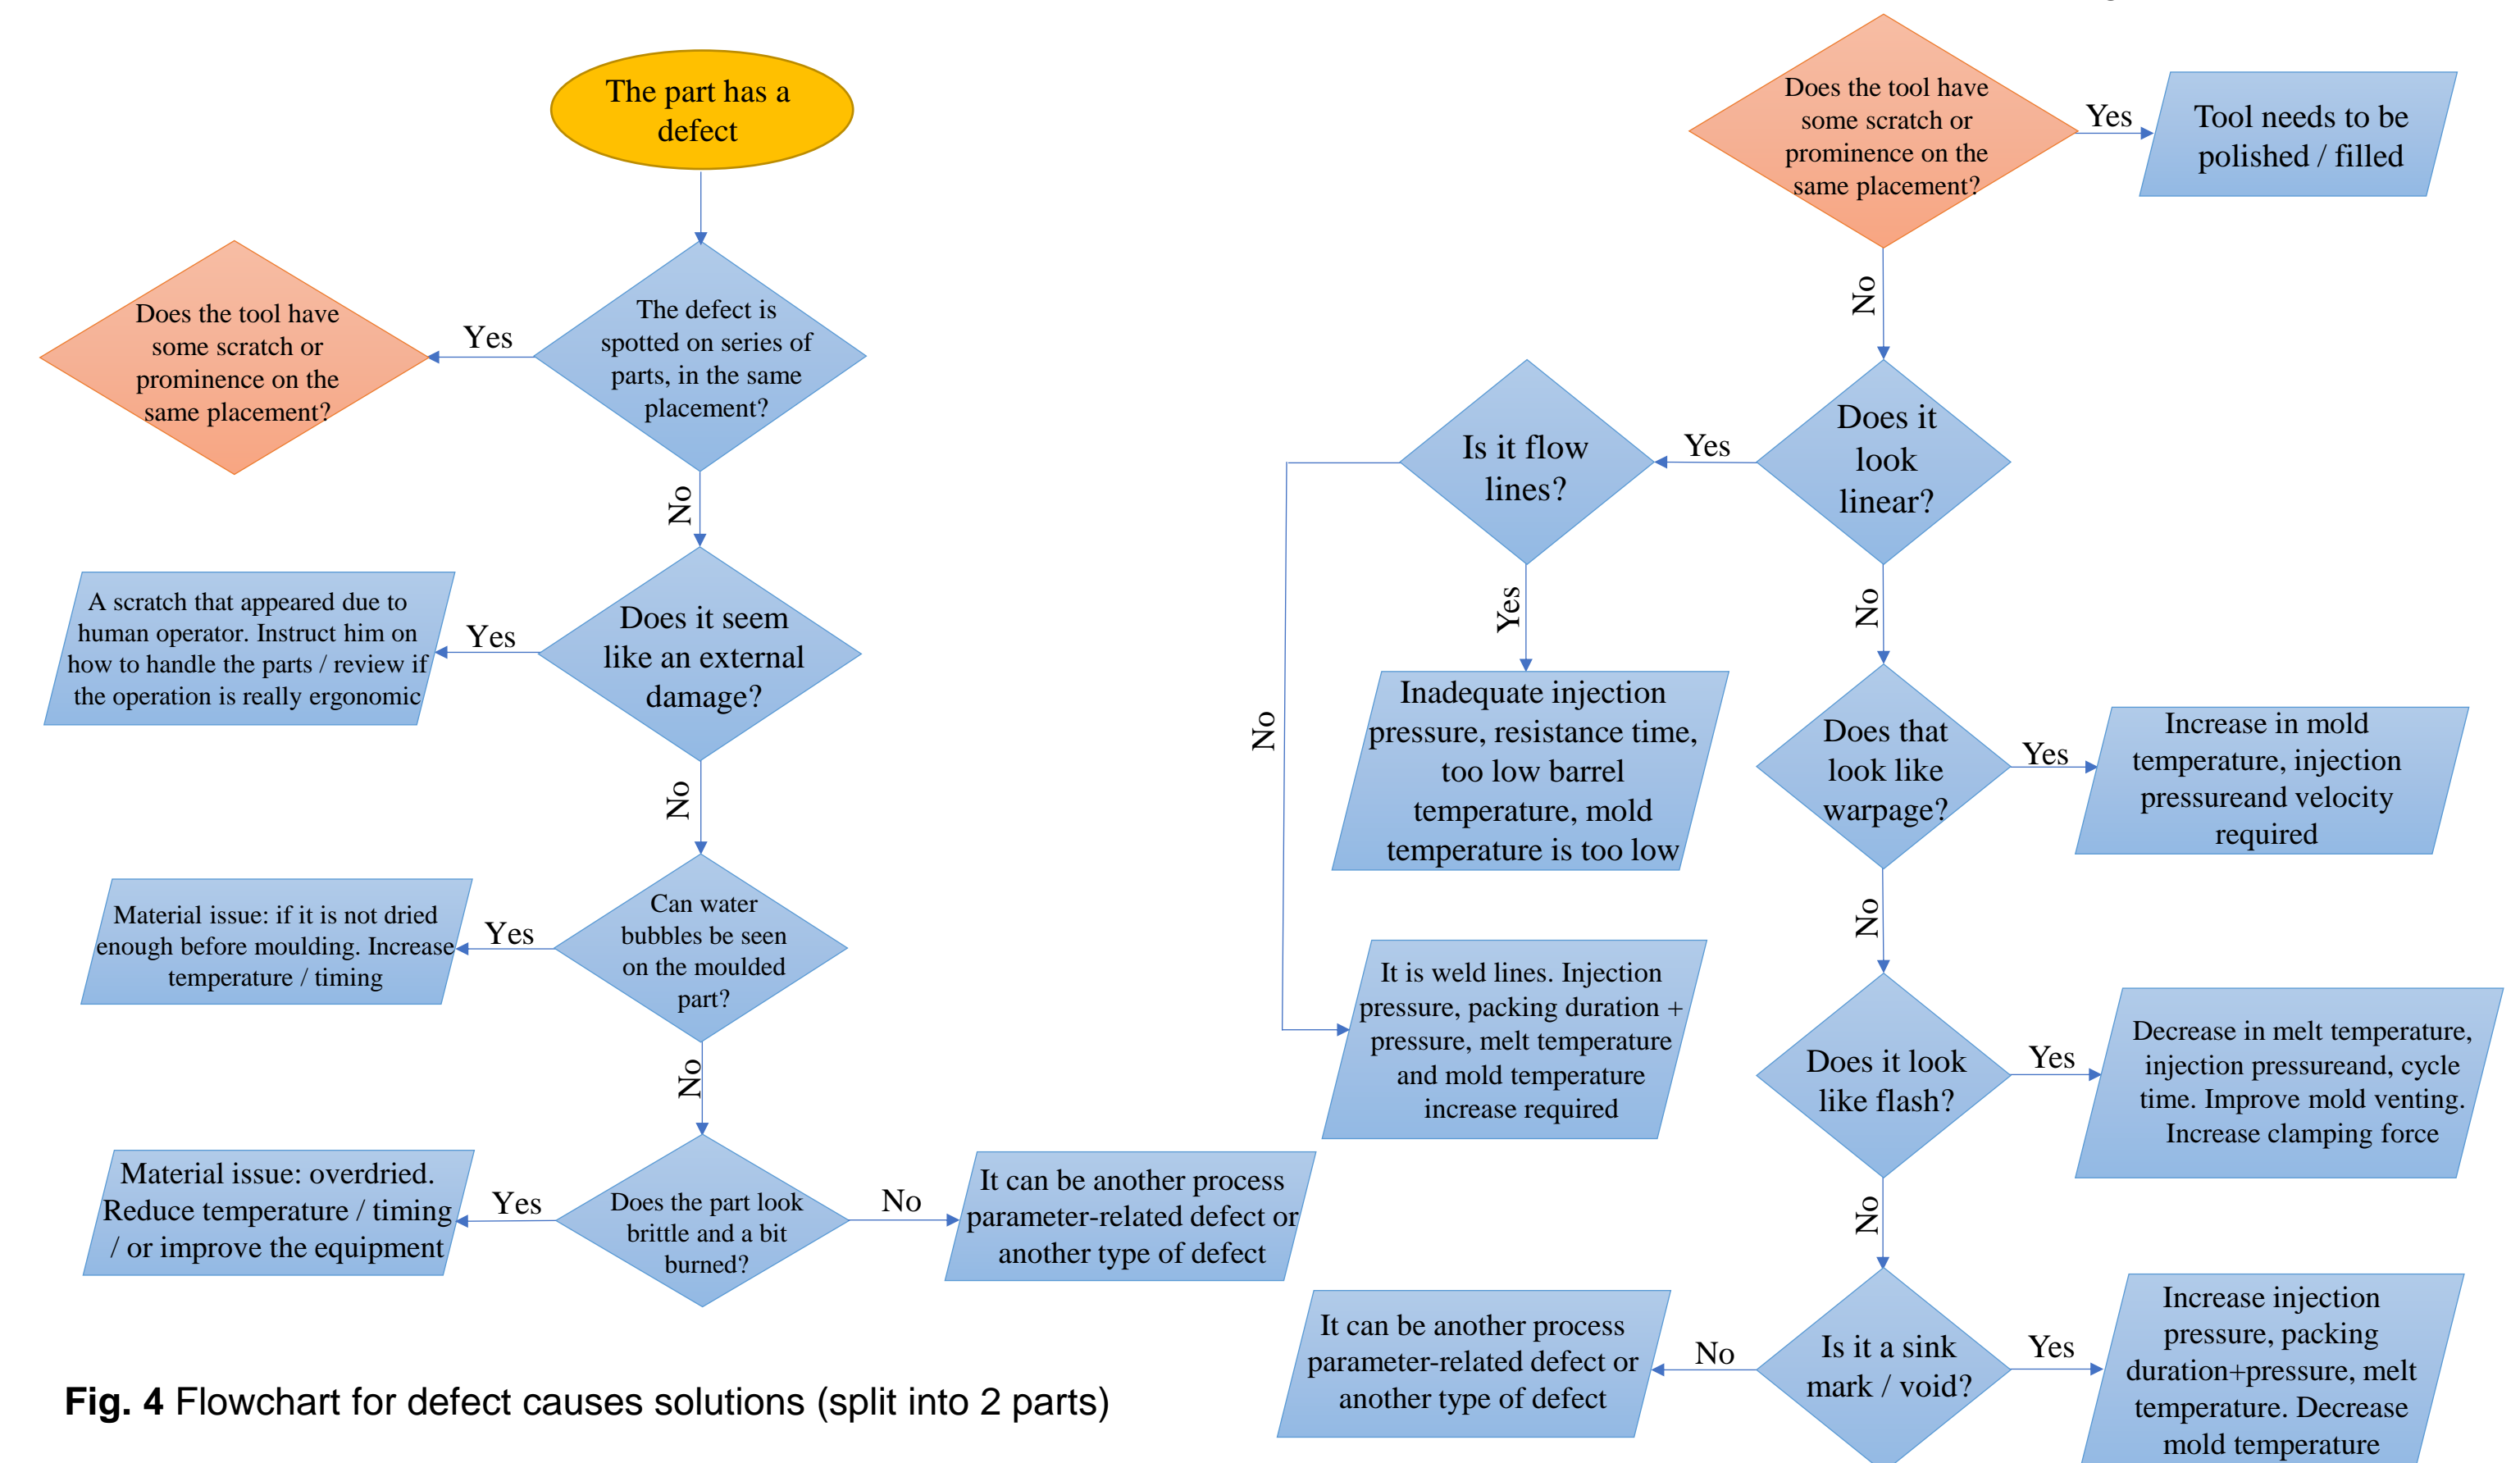
Fig. 4 Flowchart for defect causes solutions (split into 2 parts)

Some important notices after the research stage on the formulated objectives emerged. All the quality defects have causes and those causes seem to be fixable, which all can be connected into one flowchart to see all the possible map of defects. (See Fig. 4).

1. Various types of visual and dimensional quality defects are mainly related to these aspects: injection mould properties, plastic pellet material, parameters of injection moulding and a human factor.
2. Defects related with tool and process parameters are found in the same location on the high number of parts, while defects related with material quality or human factor have no specific location in the part.
3. Human factor and defect percentage in the accomplished experiment has shown the biggest correlation of all. Human-cause defects made up to 44.5161% of all the defected parts spotted. It shouldn't be generalized for all the parts and all the Plastic Injection Moulding industry as more experiments should be executed, but it all makes sense in the Industry 4.0 context, where human resources are being moved to another means in the working environment.
